# SCT End Cap Thermal Enclosures

## Observations and Recommendations on the Valencia OTE Prototype

Peter Ford, Martin Gibson, Stephen Haywood (RAL)

1 Sep 2005

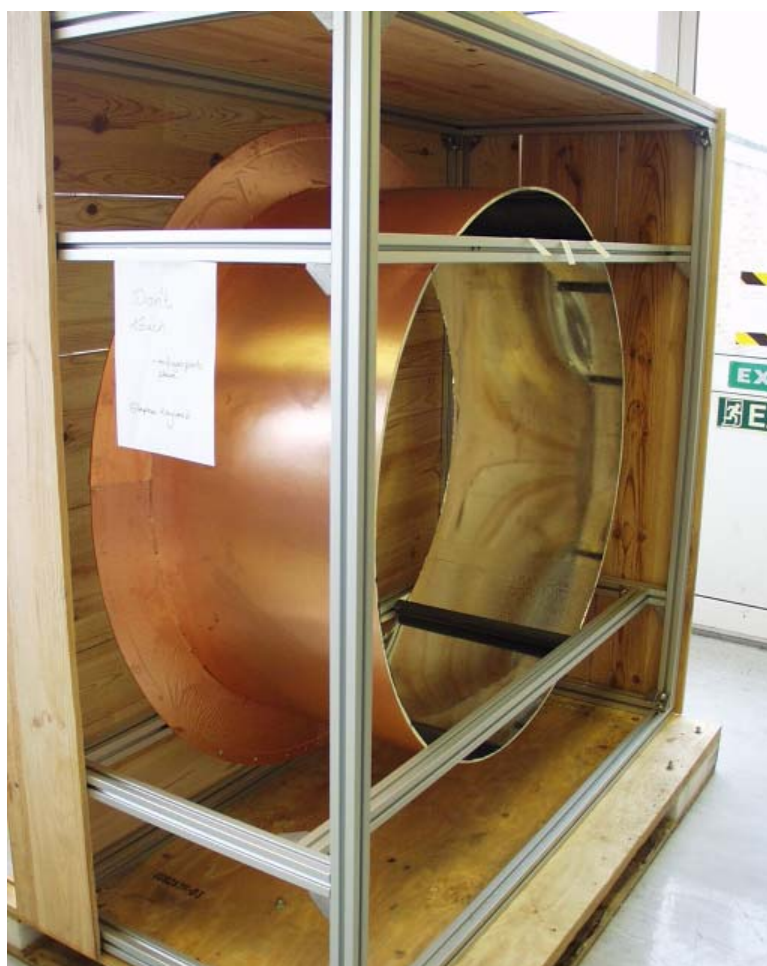
FIG. 1

The OTE prototype arrived at RAL on 25.08.05. This was the first attempt at manufacturing a full size but shortened length (0.5m) composite cylinder using Airex foam, sandwiched between an outer Cu-polyimide film and an inner aluminised Kapton film (FIG. 1).

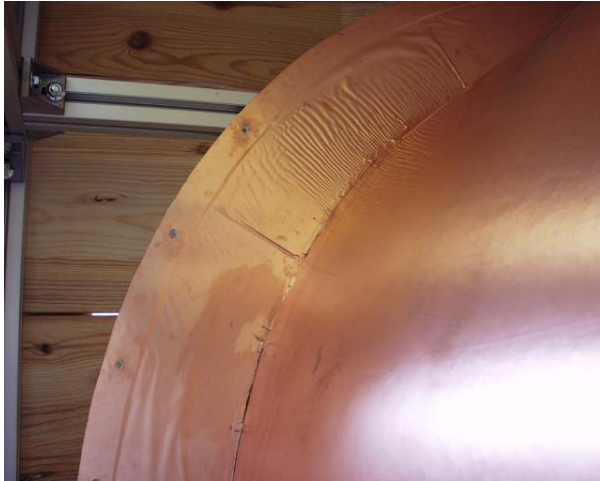
Some further attention is clearly required in the manufacture of the flange and in particular the attaching of the films to the flat surfaces of the foam. Examples of the creasing of the Cu-polyimide films and the poor adherence of the aluminised Kapton to the foam is shown in FIG. 3 and FIG. 4.

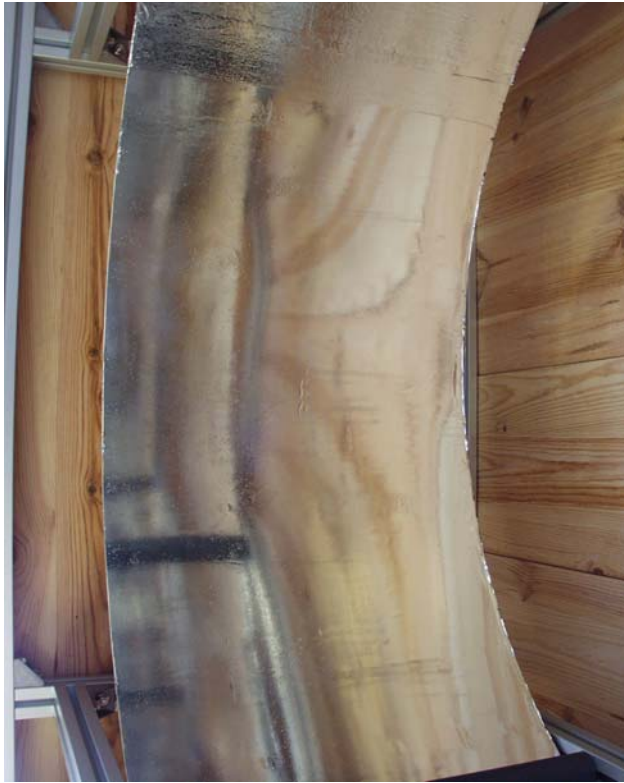
FIG 5  
Good inner surface.

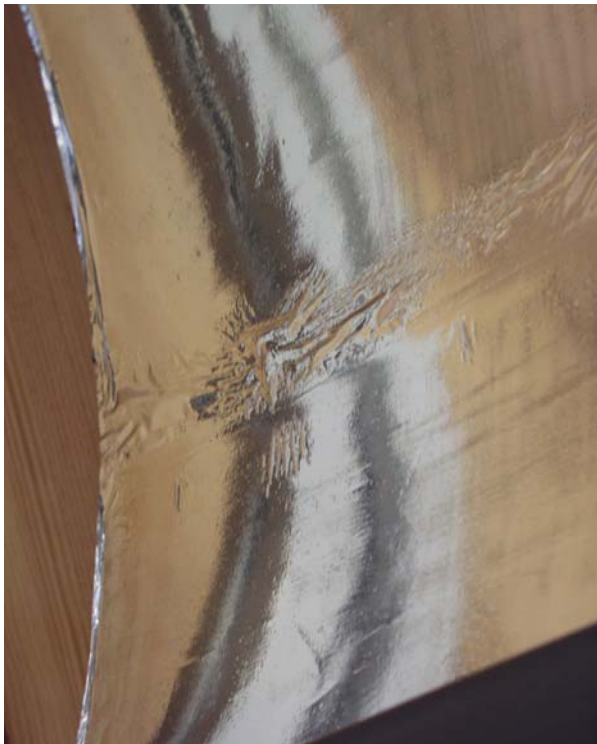
1. Inner surface: Mainly good surface, although some areas where Al-Kapton not stuck down well and creased (3 strips each of roughly 3 cm wide). See FIGs 6 & 7. The main reason for concern is regions which might catch on the Rails or other features on the End-cap.

Fig 6 shows the creases in the open side of the tooling. It can be solved by making coincident this sector with the strip of Al-kapton not glue initially to the Airex at this point and gluing it later on.

FIG 6  
Imperfections on inner surface.

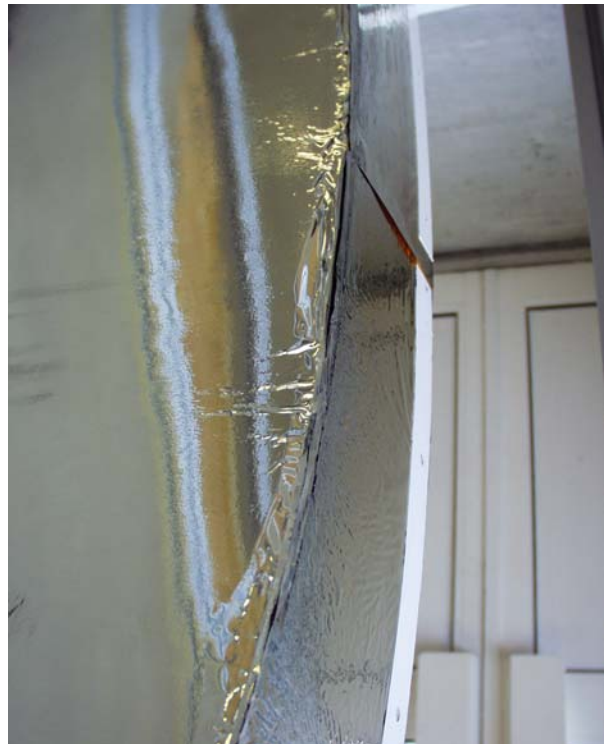
FIG 7

Fig 7 shows something to be improved. The edges of the cylinder must be better glued. It can be solved by gluing it in a second step, as done at TRT.

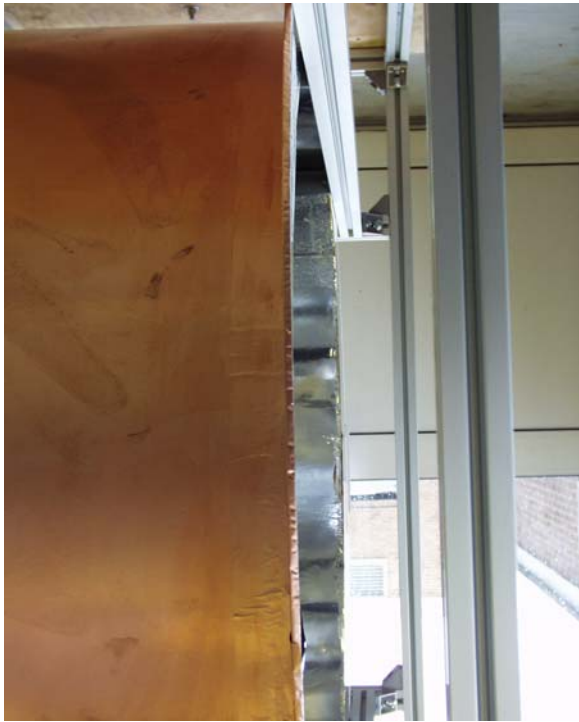
8. The Flange is not perpendicular to the Cylinder, by several degrees in parts – it tends to bend away from the Cylinder.

FIG 8  
The Flange is not flat.

The tooling was not levelled. There is a procedure to do so that will be used from now and on.

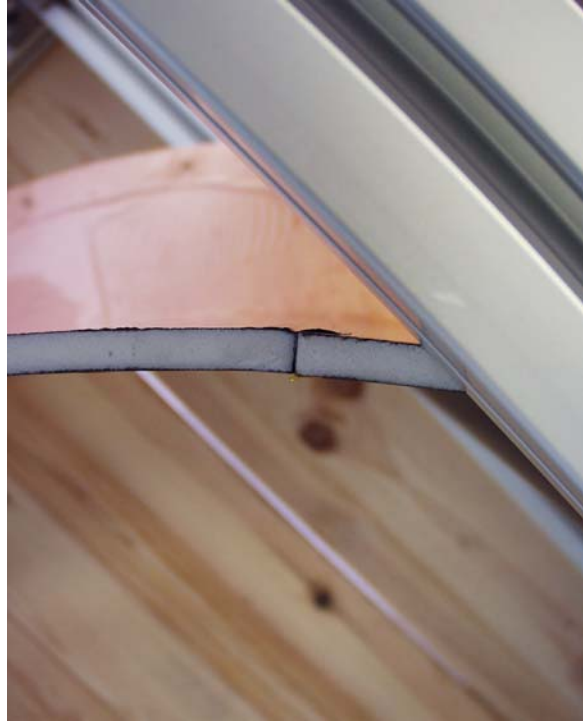
3. We have some concerns that the adhesion of the Cu-Kapton to the foam may be variable – a “tap test” suggests some areas of delamination, as does examination of the cut edge. It would be interesting to peel open one of the early Valencia prototypes to examine the adhesion.  
This is probably not a significant problem, but variable stresses may lead to distortions. Pre-tensioning the Cu-Kapton should reduce this effect.

4. Joint: There is a discontinuity of 2 mm longitudinally. This indicates that the Airex was not square on the Mandrel and may account for the observed distortions of the Flange (see below).

FIG 9  
The Airex joint, showing some delamination.

The cutting of the Airex is good and we try to positioning it precisely edge to edge, but when gluing there are movements that spoil the alignment so this discontinuity is done. To solve it we will add a stopper rigidly fixed and in contact with lateral of the Airex foam to avoid displacements.

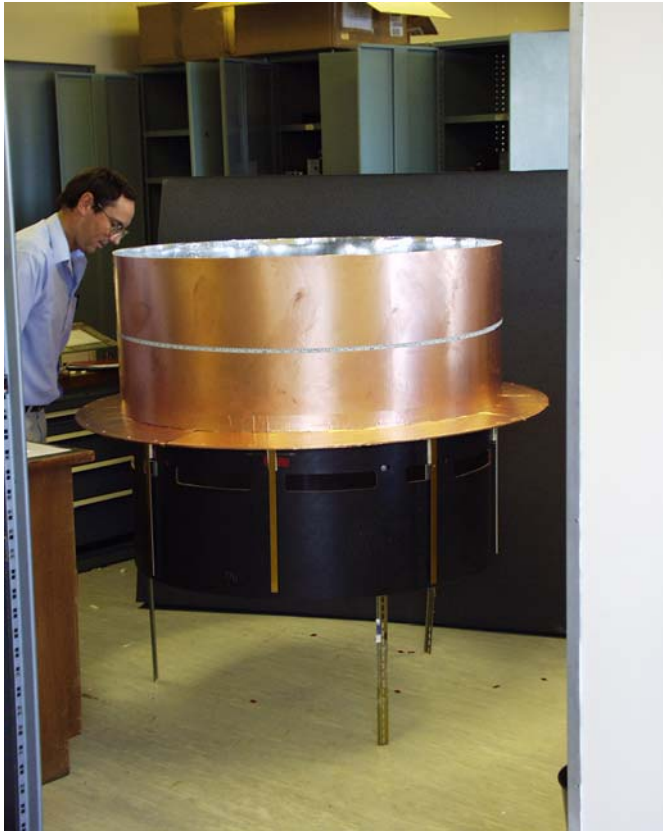
It was found that the OTE Prototype slid on to the STC relatively easily with several mm excess in parts – consistent with the measured diameter. At the Flange-end, there was very little clearance – the proximity seemed to be determined by the imperfections resulting in the inner radius of the Flange being slightly less than that of the Cylinder at some places. Towards the middle of the Prototype, the summed gap between diametrically opposite Rails was 6 mm at one extreme, and 3 mm perpendicular to this (see FIG. 13). The location of the gap could be easily modified by moving the Flange.

FIG 12  
Prototype OTE on STC.
