Status of Module Production in Valencia

S. Martí i García
IFIC Valencia

- Site production status: up to 10th/June/2004

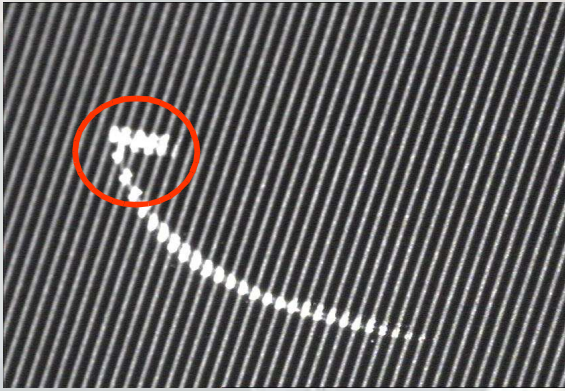
-Broken ceramics

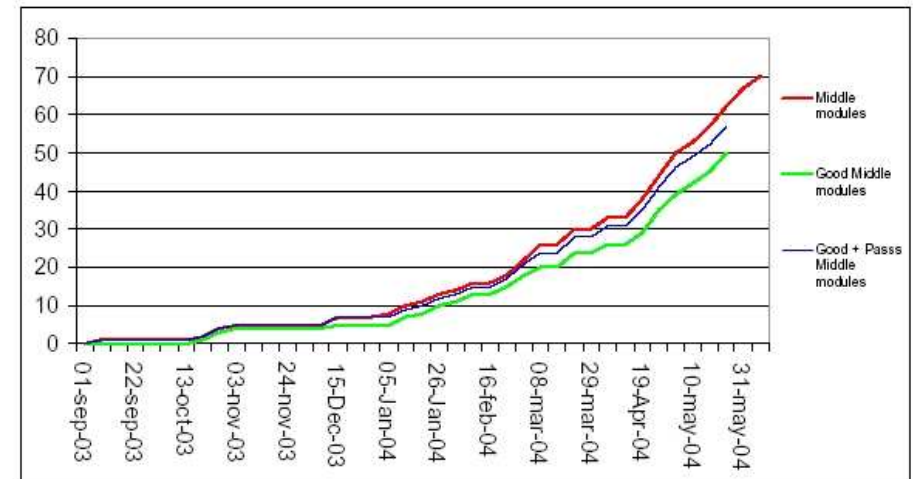
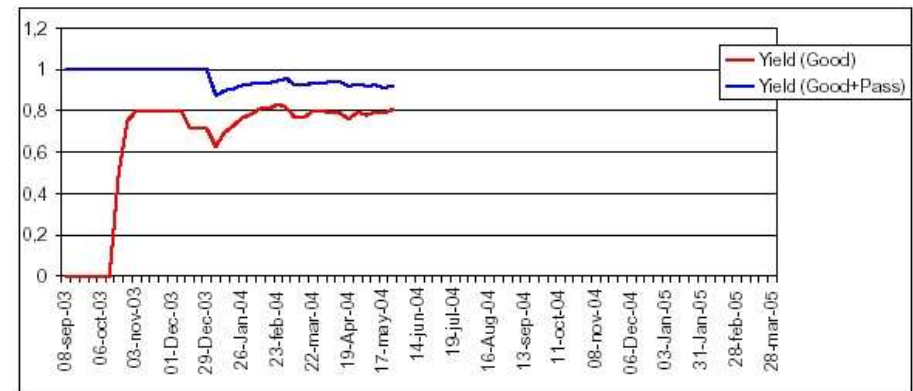
Production 9-6-2004

Middle module production

- Current production rate is 5 modules/week
 - Original schedule was 4 modules/week
 - Assembly of middle type modules only
 - Could do 6 modules/week but jig Middle-1 is not working properly
- Bottle neck is QA testing
 - Wafers IV measurement
 - Bonding
 - Metrology: intermediate and final
 - Thermal cycle (30 hours)
 - Electrical tests (28 hours)
 - Visual inspections
 - Components testing

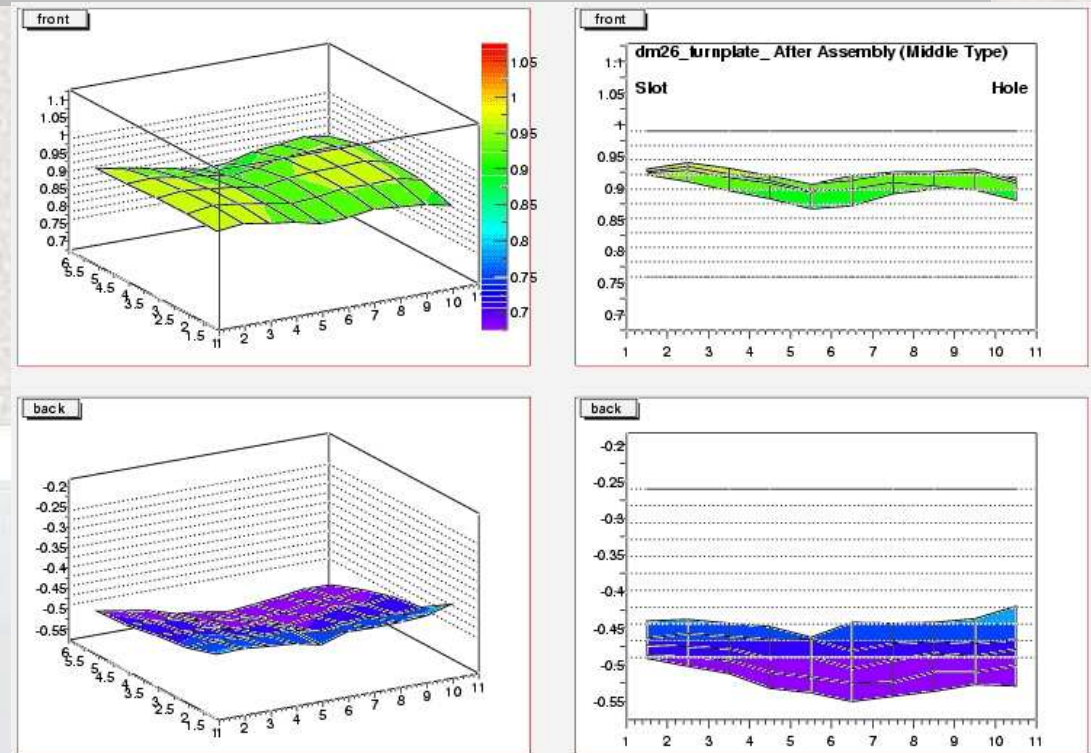
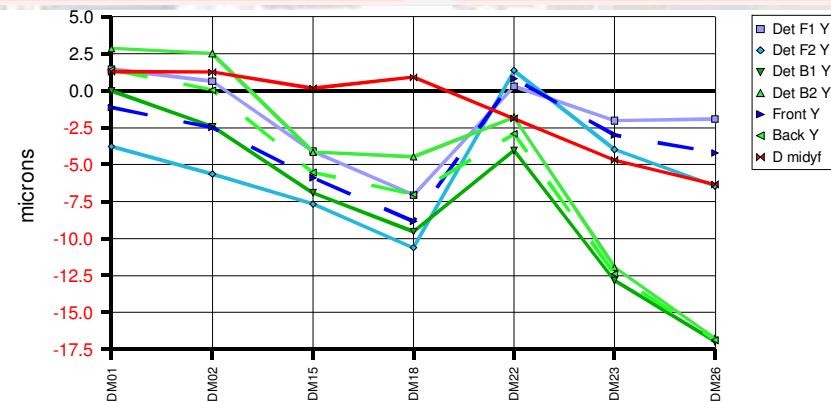
Assembly jig: Middle-1

- Modules assembled with jig middle-1 are out of mechanical specs
 - Effects seen in: midyf and Z-profile of back side
- Up to 3 dummy modules assembled with many corrections.
 - Back side wafers do not return to their alignment position

No solution found yet !

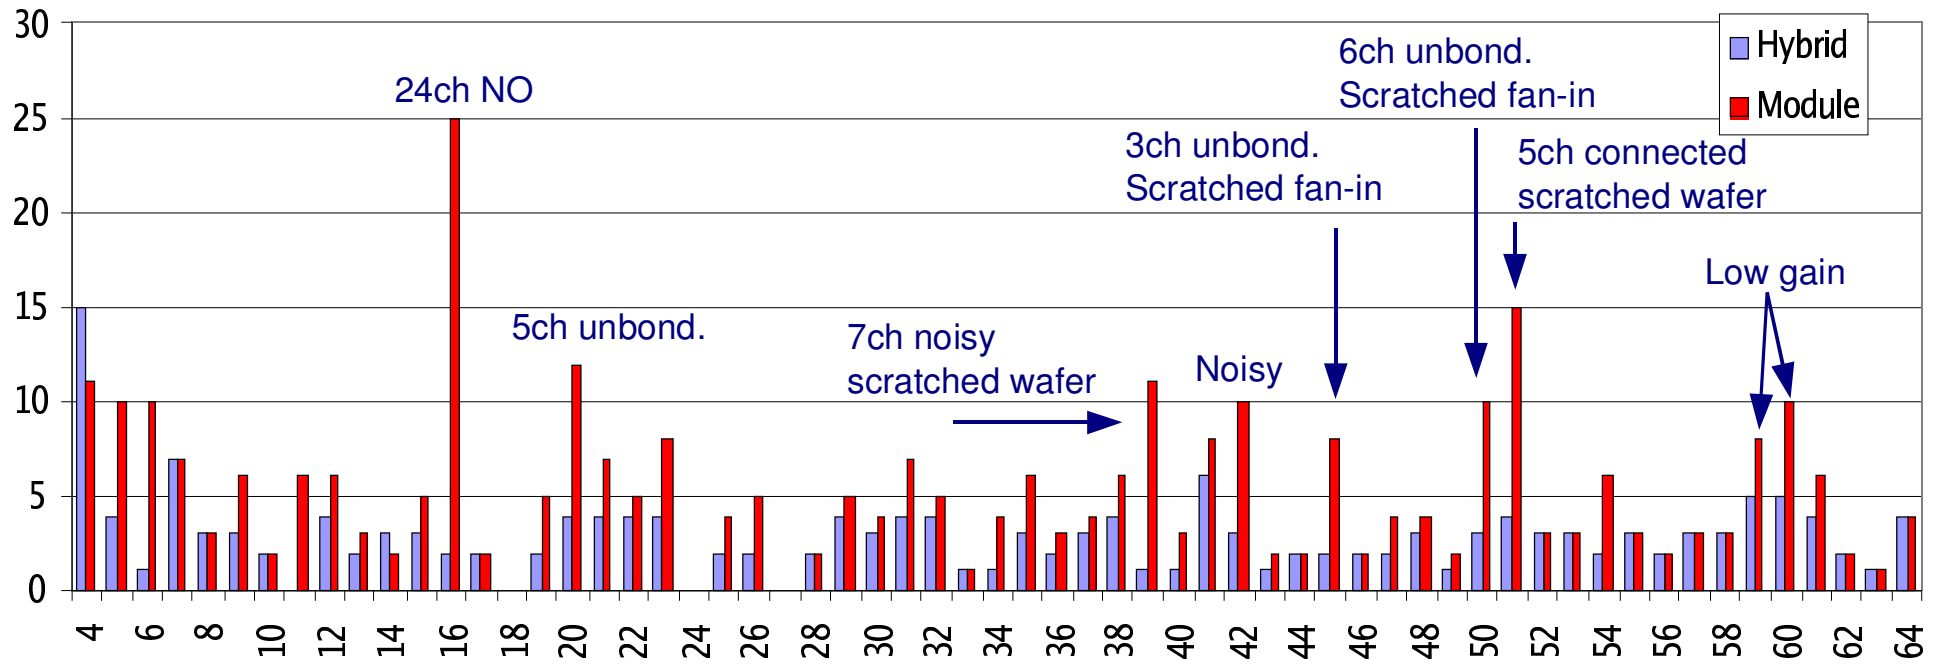
- Defect channels (on bare hybrid and after module completion)

- Hybrids :
 - M042: difficult to establish digital communication. Afterwards a bit noisy
 - M057: E13 strobe delay had do be set by hand to 24

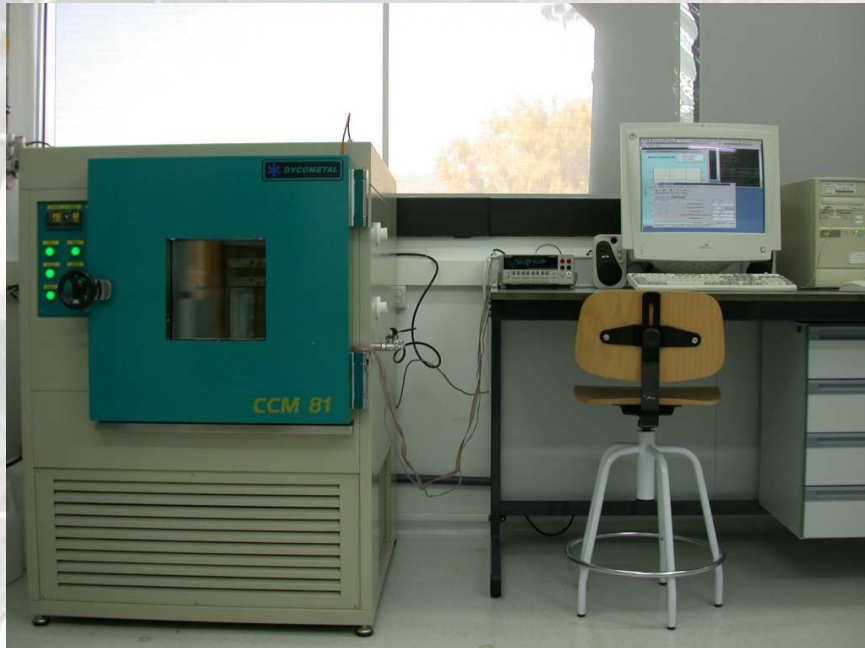
- Thermal cycle setup in Valencia

- Temperatures:
 - 30C \Rightarrow +35C
- 10 cycles
- Online
 - a) humidity (dry compressed air flow)
 - b) temperature (used to fix the 30 min dwell time)

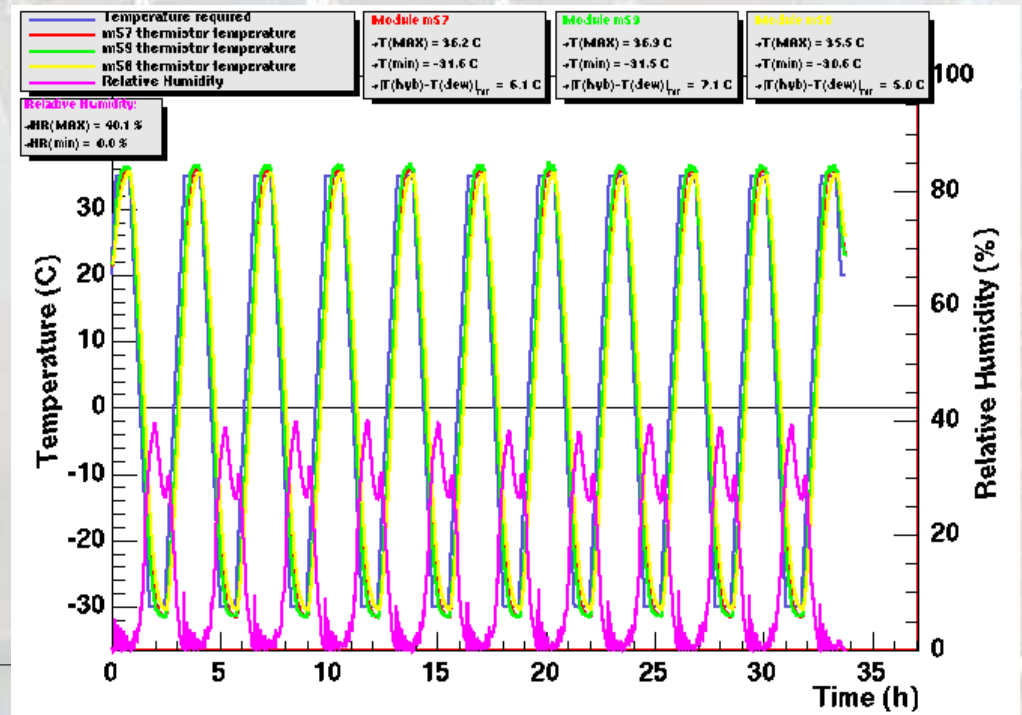
- Large statistics allows to perform systematic studies

- Thermal cycle data \Rightarrow

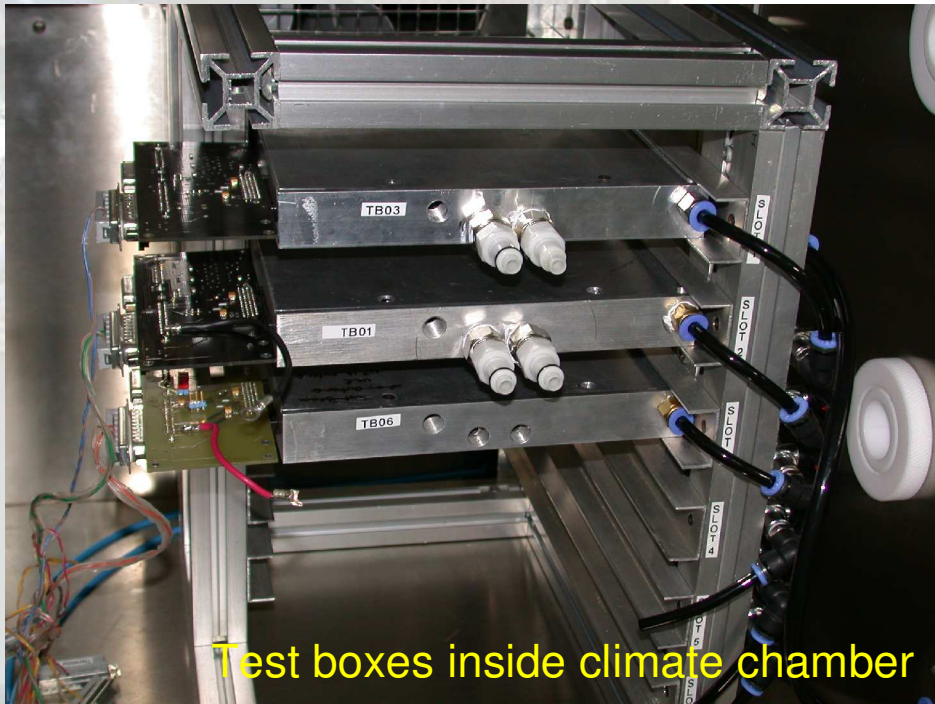
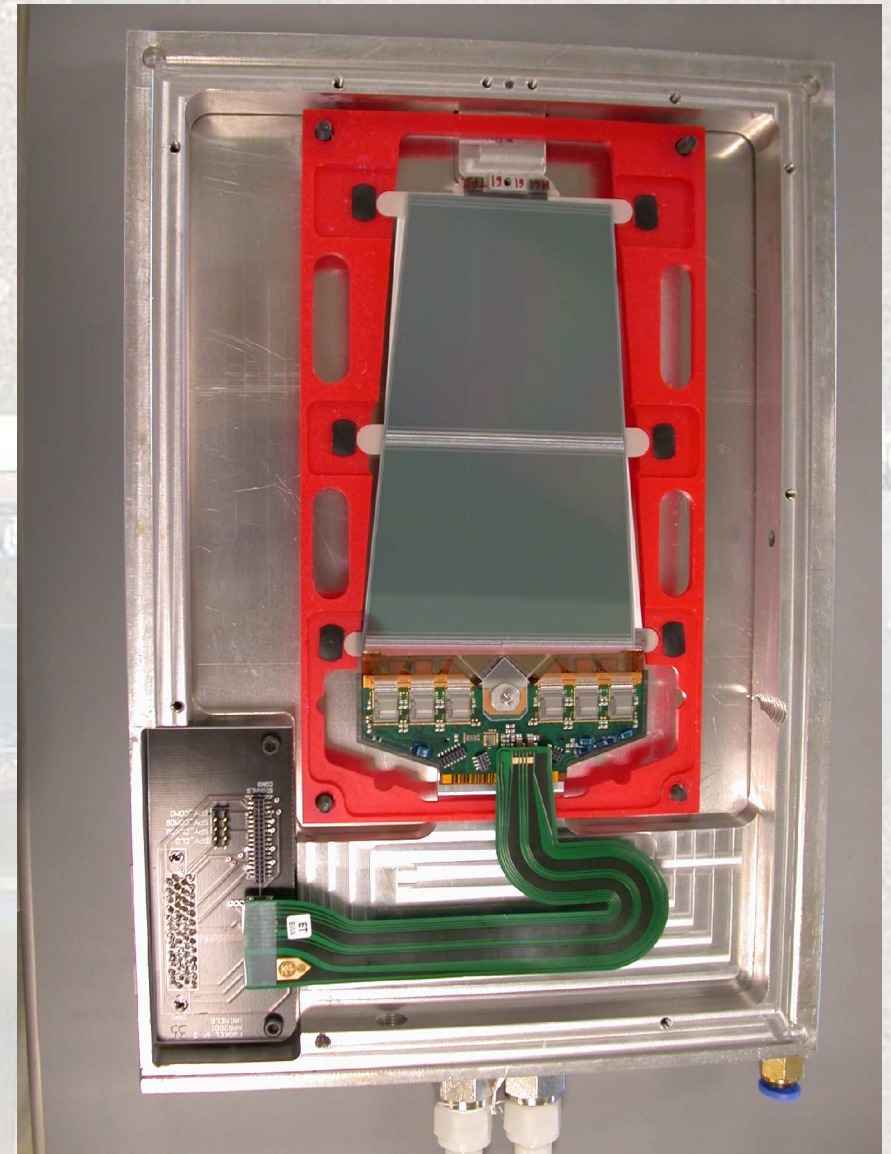
- Module holding during TC:
 - Modules located in a test box
 - Module resting on cooling blocks
 - Hybrid side: without nut
 - Far end: free
 - Spine wings: free

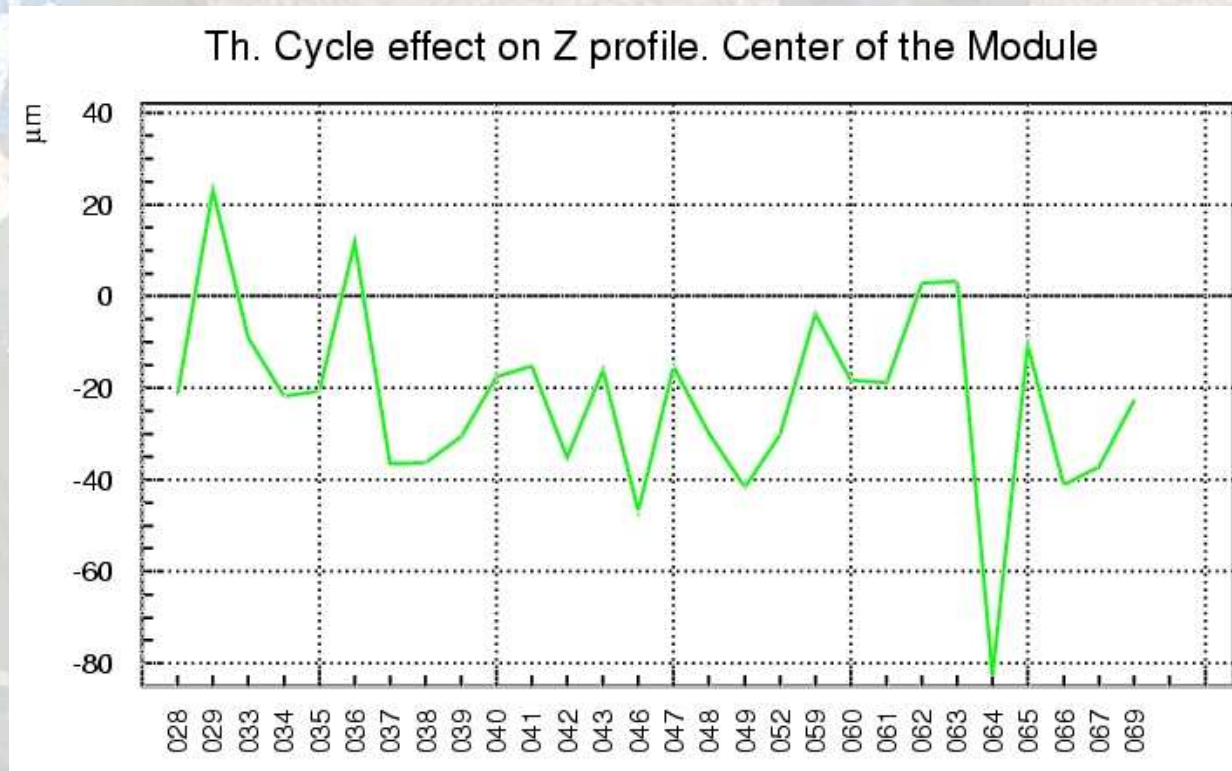
Z profile summary

- General trend: modules bend during thermal cycle

- A dummy module was cycle back side up. After cycling it exhibits the same behaviour as the rest.

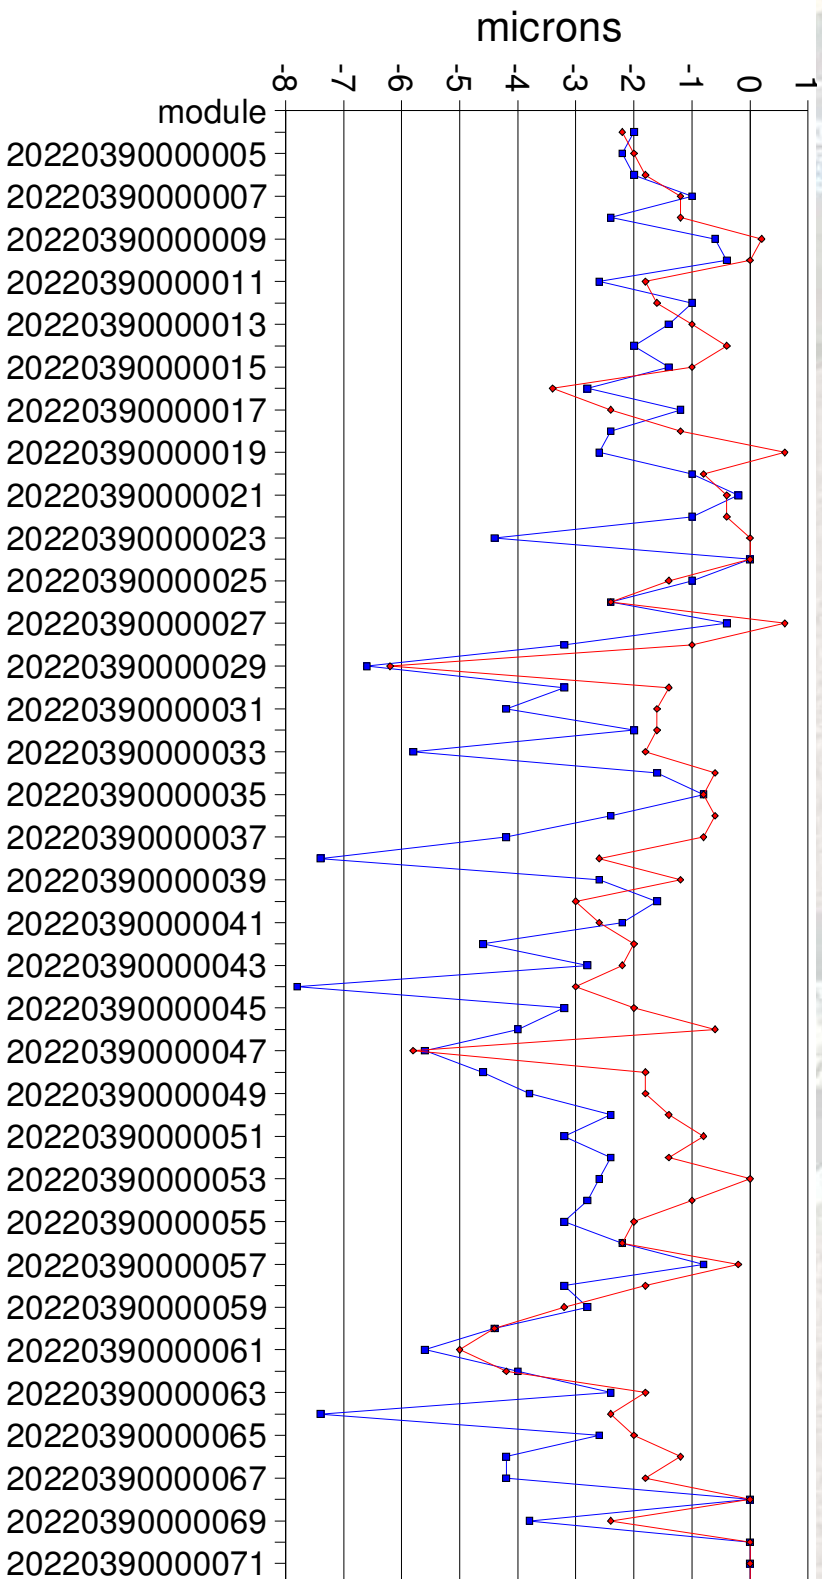
- Thermal cycle affects **sepf** and **sepb**
 - Both parameters decrease after the cycle
